1983 Jaguar XJS Interior Wood Trim Repair and Refinishing

The following describes and shows one method of wood trim repair/restoration/refinishing for wood trim on Jaguar cars, specifically this 1983 Jaguar XJS, although the wood trim should be the same in all similar years.

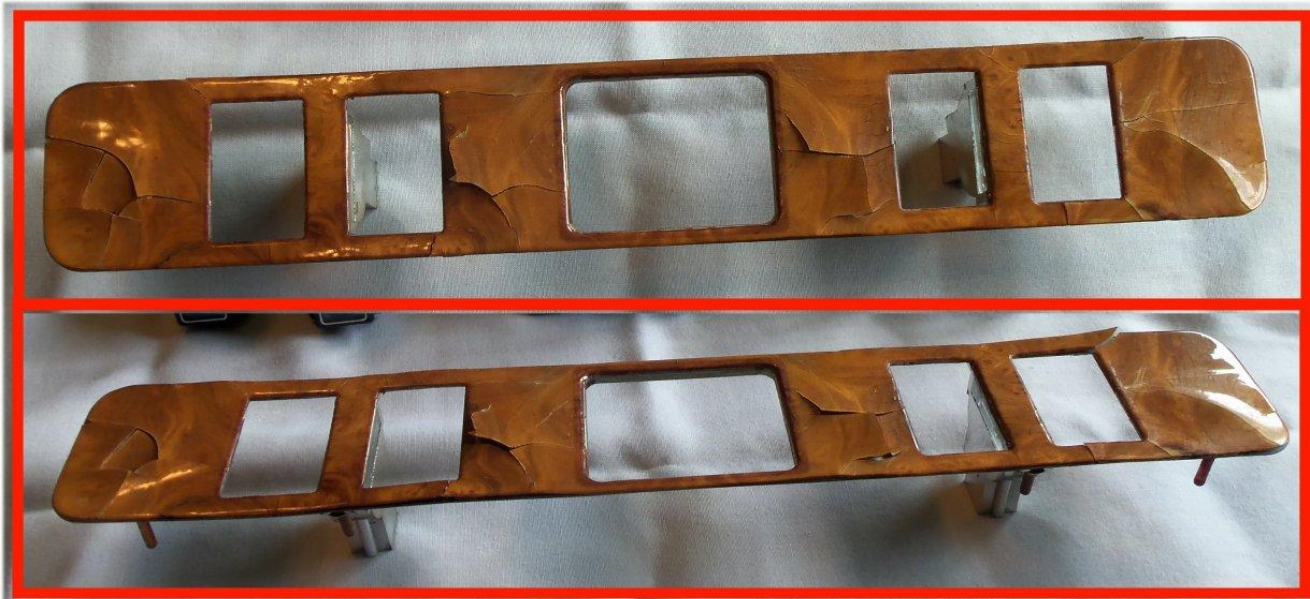
The wood veneer trim around the switches and the clock were in the worst condition, with many cracks with the cracked veneer lifting and peeling away from the metal backing. My intent was to save the original veneer and repair/restore/refinish it as close to the original look and condition as I could (with the realization that I was not a master wood worker nor did I have all the tools which would likely be necessary for such work) – with that in mind, I set about considering various ways to save the original veneer. I started with the worst piece first ... what to heck, if I couldn't do the worst piece and had to replace it, no harm, no foul, but – if I could repair/restore/refinish the worst piece, then I should be able to do the same with the wood veneer pieces which are not in as bad condition - seemed logical at the time.

This wood veneer was really worse than it looks in these photos as these photos do not show all the cracks and splits, or all of the lifting/peeling of the veneer. The photos which follow show the cracking, peeling, and lifting in better detail.

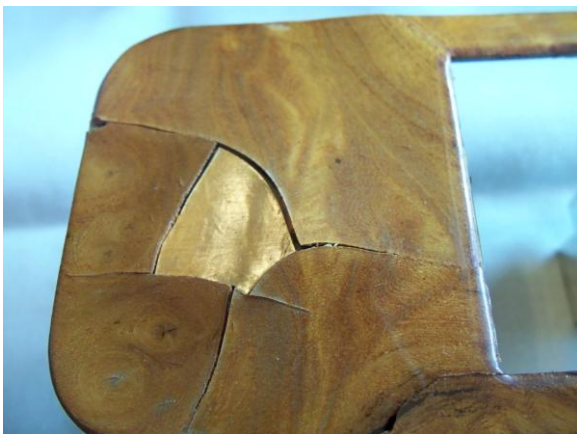
The center piece of veneer fell out when the switches and clock were removed.

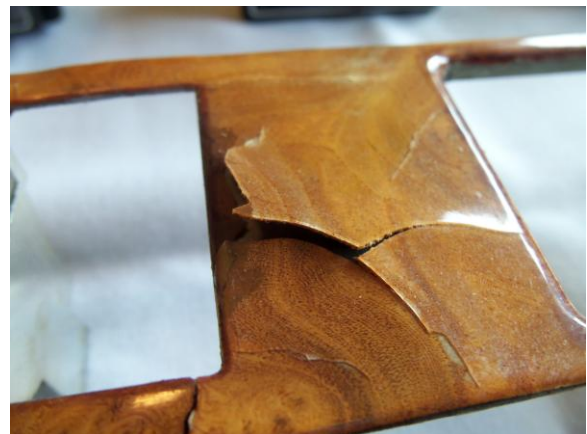
Almost none of the veneer is still adhered to the metal back in this part between the left switches and the clock to the right.

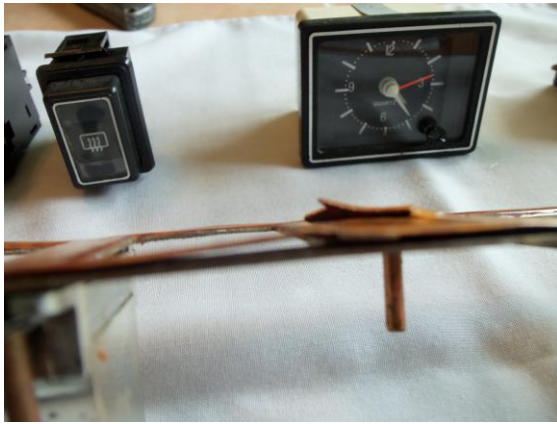
The two thin strips across the top and bottom of the switch are no longer adhered and are cracked and broken.

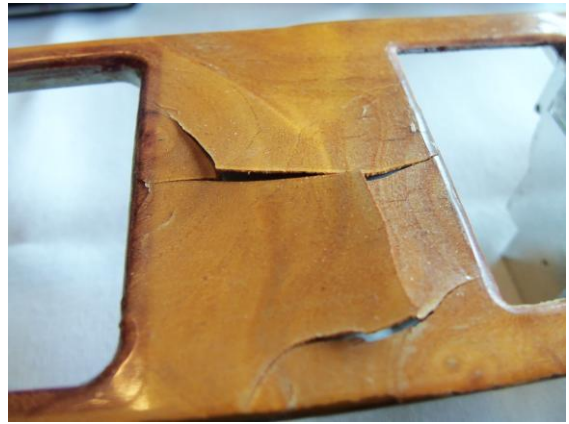
Almost none of the veneer is still adhered to the metal back in this part between the clock and the switches to the right.

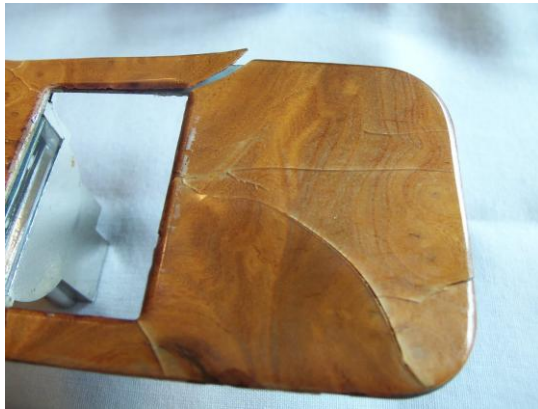
The left end is also cracked and does not look to still be adhered very well either.

My original intention was to glue the loose veneer back to the wood backing ... but the backing turned out to be metal and the metal backing prevents that, as does the stiff and curled veneer (I didn't want to risk cracking/breaking the thin wood veneer any more than it already was).

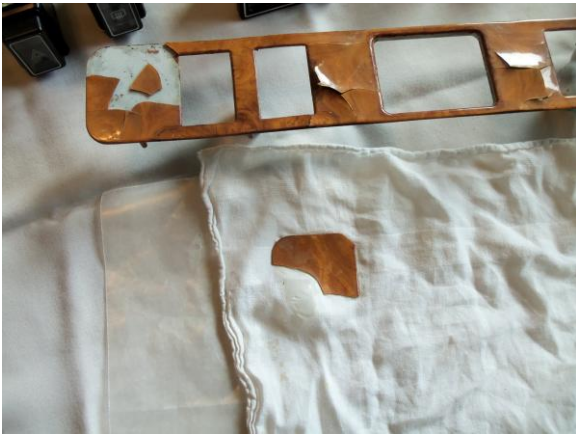
I started at the upper left corner as that piece practically fell off when I tried to remove it, and the piece below it had already fallen off when I removed the switches.

The piece on the handkerchief has already been glued in place and is dry.

This was my starting point for removing the puzzle pieces from the metal backing and making a completed but separate wood veneer piece I could then work with.

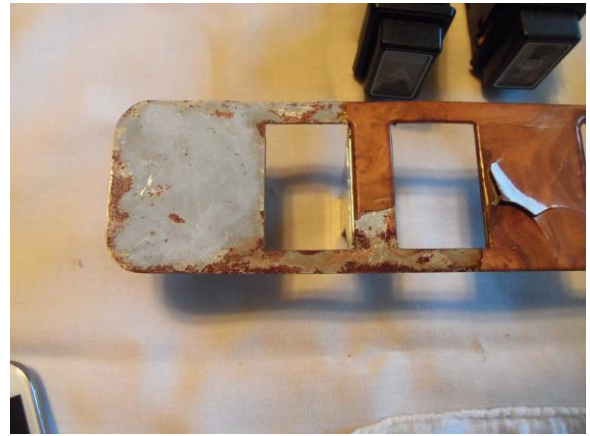
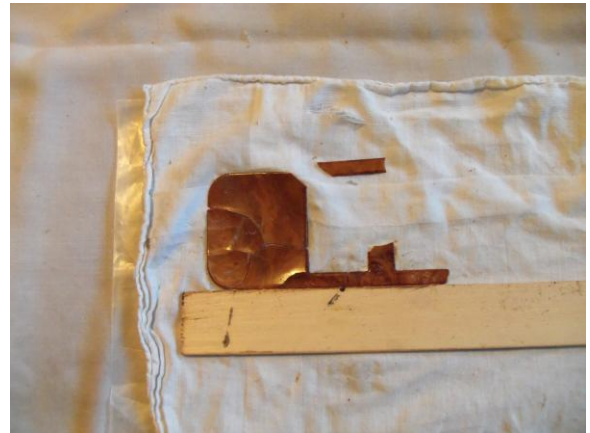
Progress! Getting ready to glue the small piece at the top in place, but ... I need a guide to know where to place it.

A putty knife and utility knife work well for removing the pieces of veneer from the metal backing.

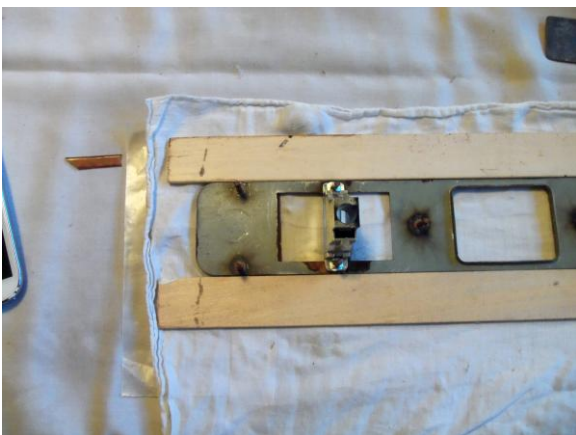
I placed the metal backing over the pieces I had already glued in place and used two paint stirrers as guides.

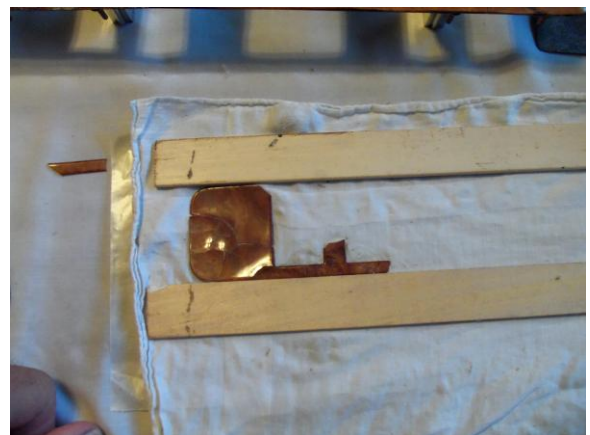
Now I had the left end, and guides for the top and bottom of the veneer.

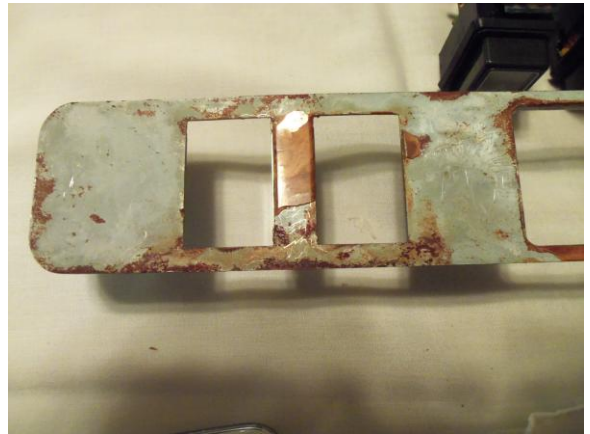
Some pieces are actually still adhered in place pretty good – Darn! Loose pieces are easier to work with.

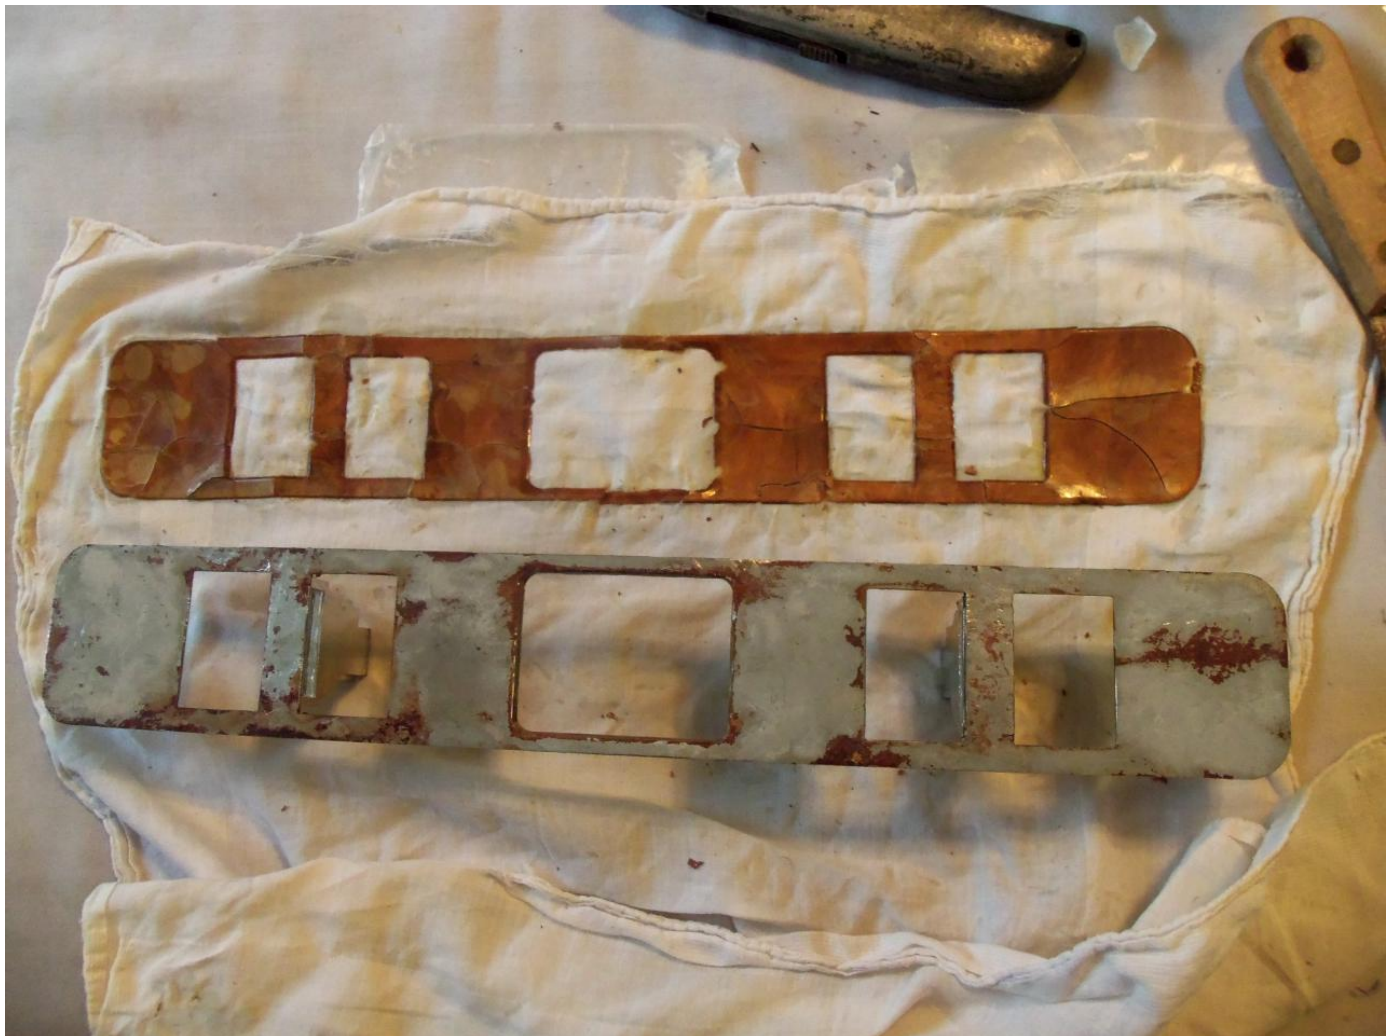
Mostly done removing the veneer puzzle from the metal backing and gluing to the cloth. A few small pieces of the wood veneer are all that are left to be removed.

The veneer piece is definitely taking shape and now looks like it might be feasible to repair and refinish.

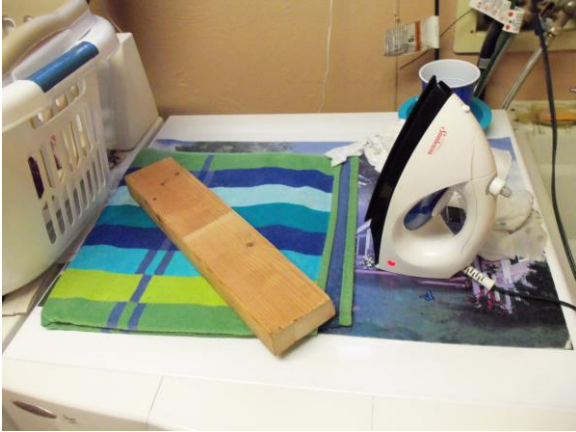
This is my “un-bending form” that I will use as the “form” to which the steam un-bending will form the wood veneer to (flat).

I decided that I could make the wood veneer lay flat using a method used for bending wood – after all, I was simply “un-bending” the wood, so the method should work: steam and pressure.

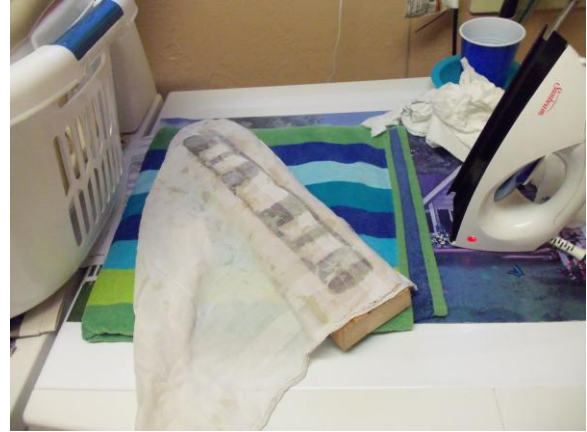
The wood veneer is on the “un-bending form” with the cloth side down; a sheet of wax paper has been placed over the wood veneer, which is facing up.

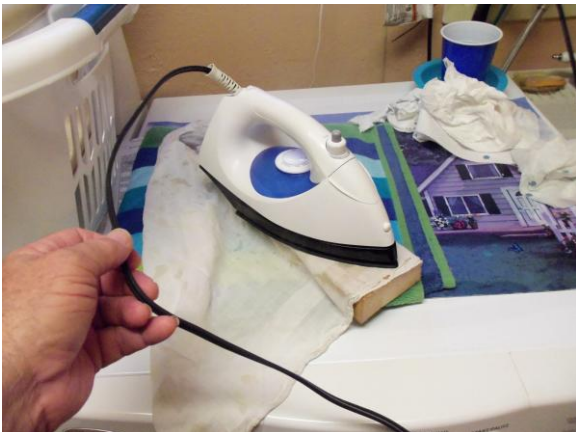
This is my steam and pressure forming tool.

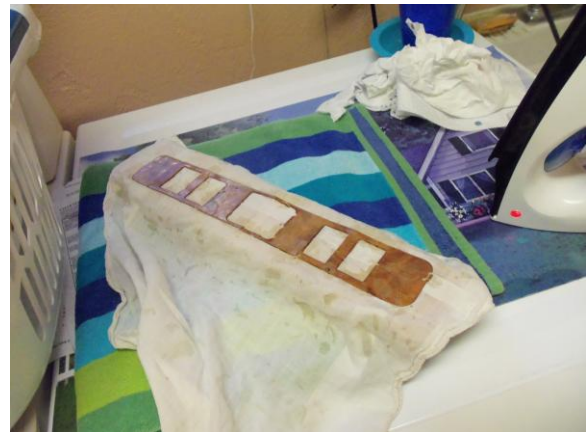
The veneer is now “un-bent” and lays flat.

The wood veneer is now flat, however, the cloth backing leaves the wood veneer too flexible – a stiffer backing is needed to keep the wood veneer “in plane” with itself such that the wood veneer can be handled and then re-adhered to the metal backing.

I used a thin but stiff piece of cardboard (which is basically wood in a different form) to glue the cloth backed wood veneer to.

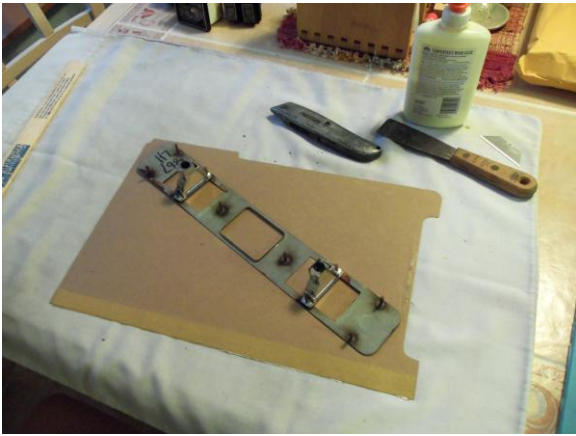
Tracing the metal backing to make the cardboard backing for the wood veneer.

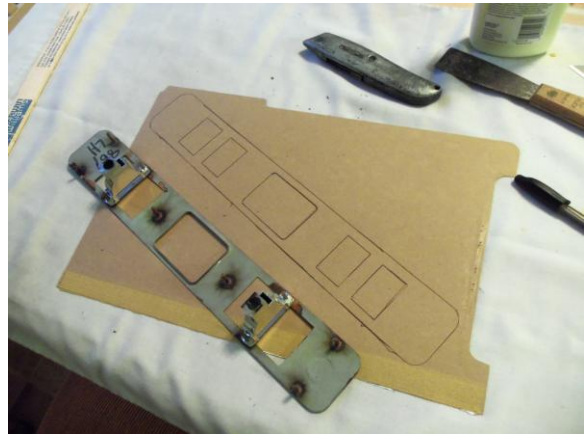
This is the traced cardboard backing.

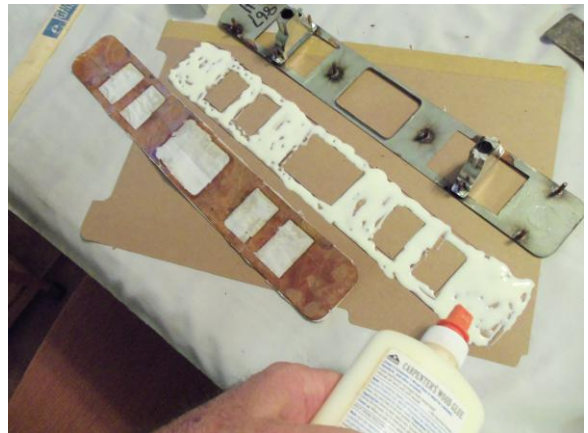
The cardboard backing is coated with wood glue, the wood veneer is ready to be placed on the glue and clamped in place.

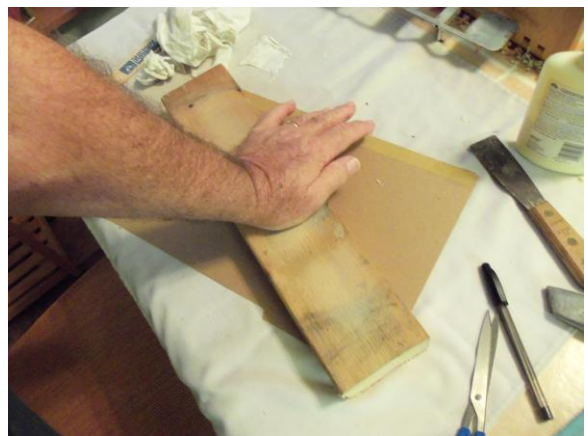
Applying initial pressure to set the veneer into the glue prior to clamping.

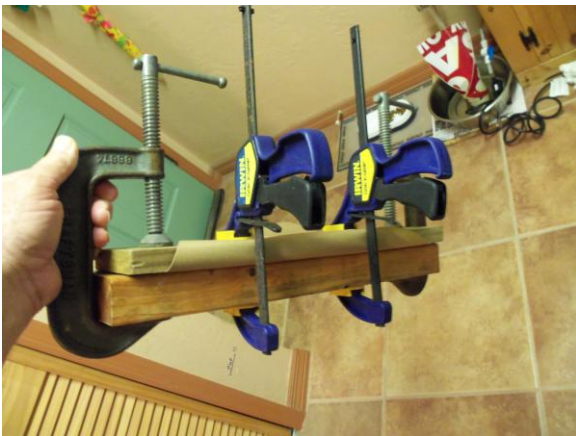
Clamps applied to flatten the wood veneer while clamping for gluing to the cardboard backing.

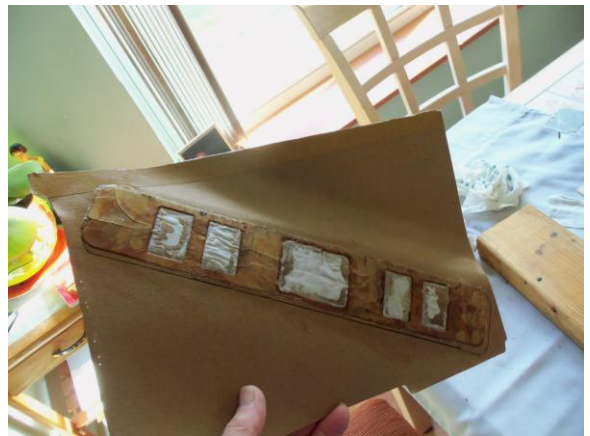
Wood veneer after being clamped overnight to glue the wood veneer to the cardboard backing and flatten the wood veneer.

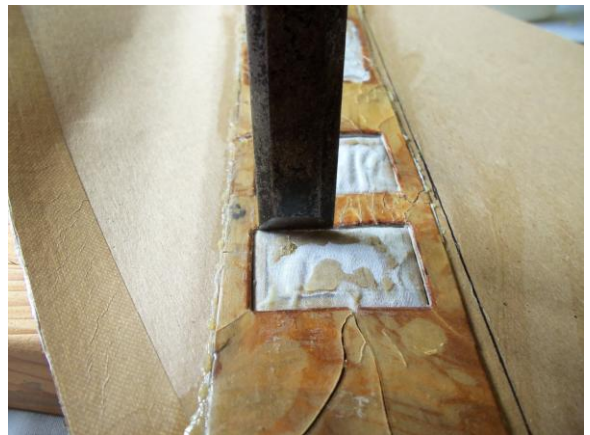
Chiseling out the cloth and cardboard backing from the switch and clock openings in the wood veneer.

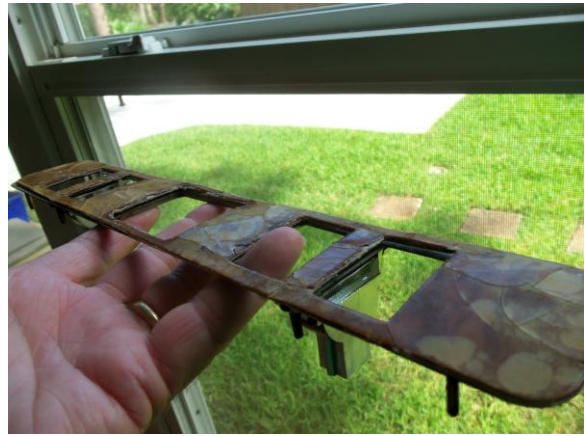
The wood veneer lays flat on the metal backing and the openings line up.

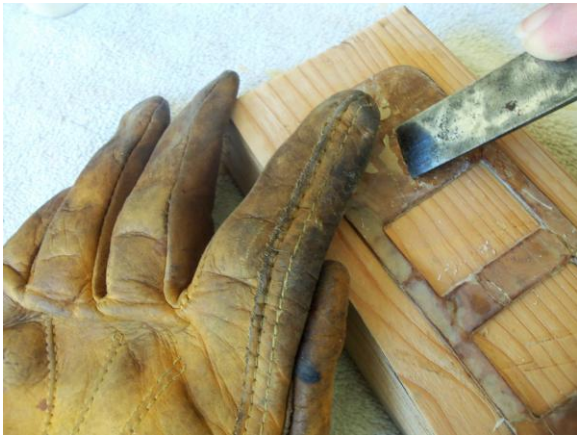
Using the wood chisel, start where the wood veneer is cracked and lifting – start the chisel under the original finish but between the original finish and the wood veneer itself.

This work needs to be done carefully so as to not push the chisel into the wood veneer below and create a gouge in the veneer – you do not want that.

Work the wood chisel under the original finish (which is about as thick as the veneer itself), making sure not to cut into the veneer, then slowly push the chisel with its flat side down on the veneer, allowing the original finish to go up the tapered side of the chisel. You may need to start the chisel with its flat side up – see photo.

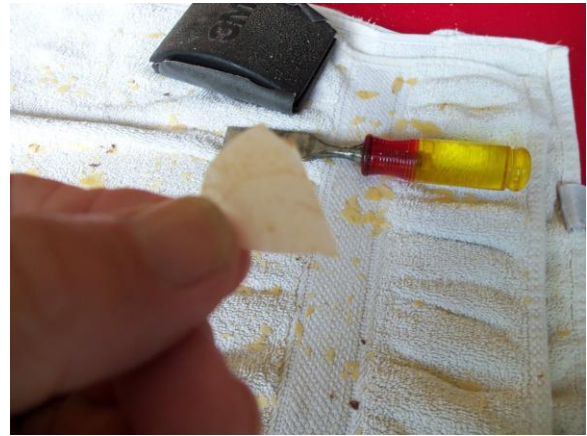
While most of the original finish will likely come off in smaller pieces, as can be seen on the towel in the background, some pieces may come loose as a larger area, I used a feeler gauge thick enough to be somewhat stiff yet thin enough that I could slide the feeler gauge between the original finish and the wood veneer and gently pushed in, loosening larger area which would pop off as larger pieces.

In some cases, when I could see a large area coming loose, I used a feeler gauge (thick enough to be somewhat stiff, but thin enough to slip under the original finish) to slip under the original finish and gently force the feeler gauge between the original finish and the wood veneer – this successfully worked for larger pieces of the original finish which would come loose in one larger piece.

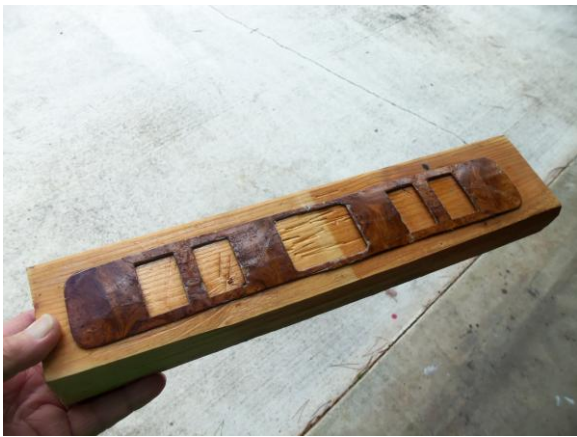
The wood veneer with the original yellowed finish removed.

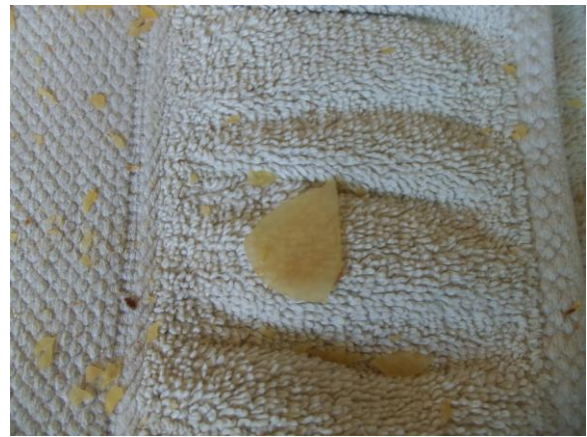
This is the original finish, which was originally clear, but it is now so yellowed that you whatever you can see through it (which is not much) looks “yellowish”.

I originally thought the wood trim in my car was some special kind of blonde burl, maybe maple or something.

As it turned out, the blonde look was just from the yellowed finish, which made it look blonde, that was all it was – 34 years of exposure to sunlight ... and my car was a New Jersey car which was not driven during the winter months, and was garage kept when not in use (I am the second owner and have owned the car the last eight years, since February of 2008). The wood veneer in a car left outside in the sun for longer periods may be in worse condition, however, if all the wood veneer is still there, you can probably repair/restore/refinish it.

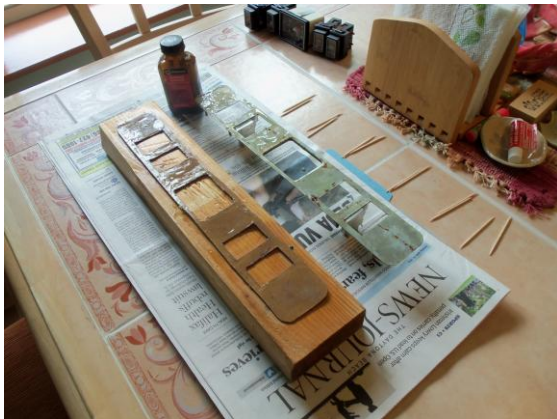
This photo shows the cardboard backing side of the wood veneer and the metal backing plate coated with contact cement.

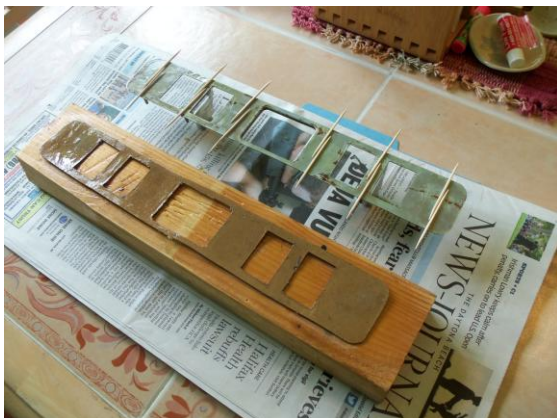
The contact as set up and is ready to be assembled.

The toothpicks you see allow the wood veneer to be laid over the metal backing without making contact.

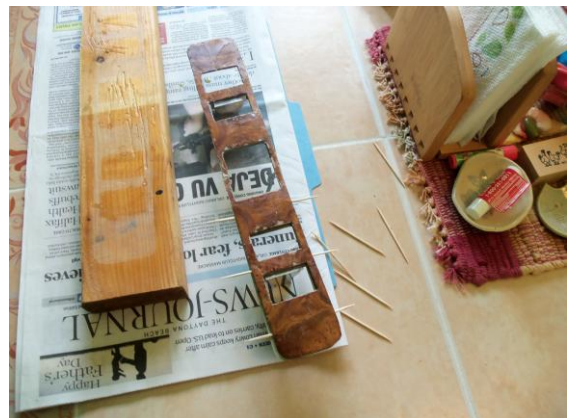
Remove a toothpick at one end and squeeze the wood veneer to the metal backing plate, making sure the two are aligned.

Work toward the other end, making sure the pieces are still aligned, then remove a toothpick and squeeze the two pieces together, toothpick by toothpick.

After matching the wood veneer with the metal backing and removing all the toothpicks, make sure to squeeze the two pieces tightly together to assure a good and full adhesion bond between the two.

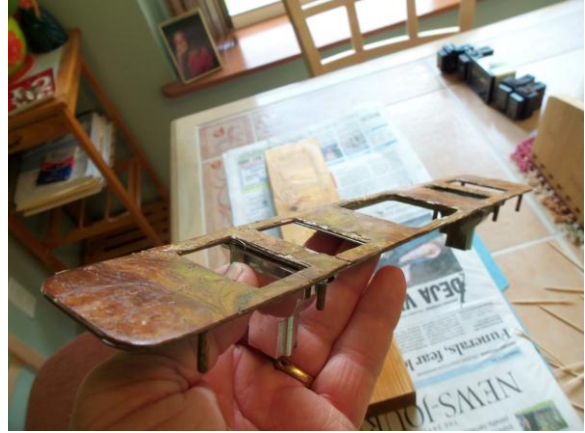
You can see some minor imperfections which need to be addressed during the finishing process.

Minor imperfections can be touched up with black lacquer – spray some black lacquer into the can's cap, dip a Q-Tip into the liquid black lacquer in the cap and touch the black lacquer end to the imperfection – wipe the excess out (lacquer dries very quickly, so you need to act QUICKLY or you may need to lightly sand some black lacquer off (another reason to spray a coat of clear lacquer on the wood veneer first, so the black lacquer or wood filler can be removed easier).

The fill in a “knot” in the wood veneer fell out, I used some dark walnut wood filler to fill the “knot”, sanded it to be flush with the surface, then it looked original behind the clear gloss lacquer coats.

You can now build up the lacquer in the imperfections using clear gloss lacquer, filling, sanding, filling, sanding and spraying the entire piece occasionally as you fill and sand.

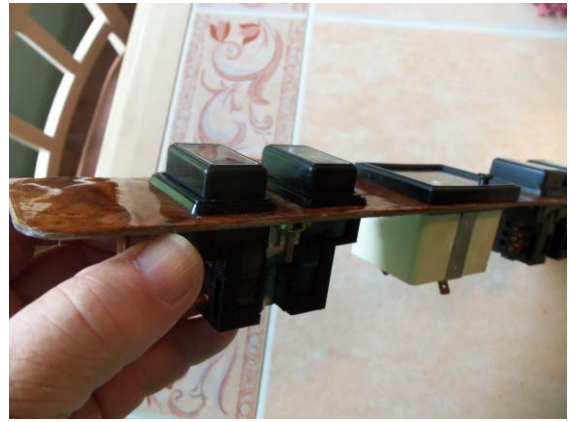
An angle view showing the surface of the wood veneer after having been repaired/restored/refinished as described above.

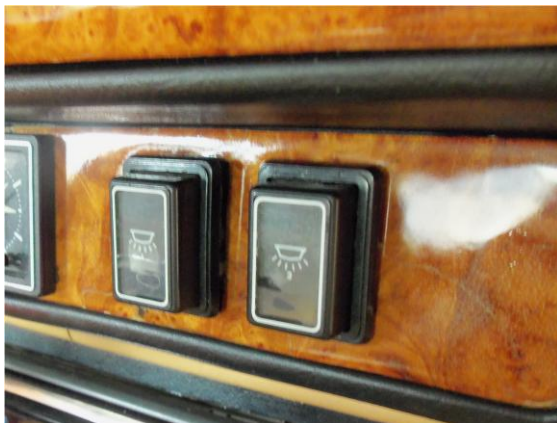
This is a close up of the installed wood veneer, you can see some of the crack lines behind the clear lacquer, but it is all flat, smooth, and glossy.

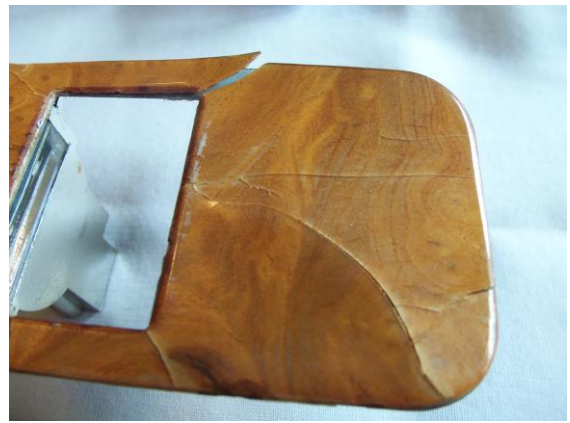
This is the same end – this is what I started with.

The large curved crack line is visible in the finished veneer, but the finished wood veneer look was well worth the effort, time, and work it took.

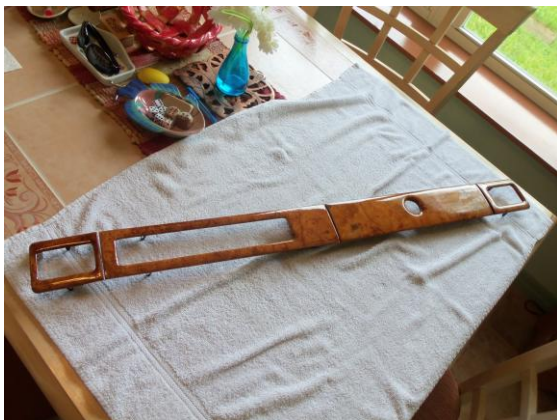
The photo to the left shows the other wood veneer trim pieces which went through the same process, except that these pieces have wood backing, which eliminated the steps up to adhering the veneer to the metal backing.
