### You Saw **WHAT** At Your Inspection?

Contractor says 'Everyone else lets me do that ... why won't you?'

Photos of things inspectors find during inspections ...

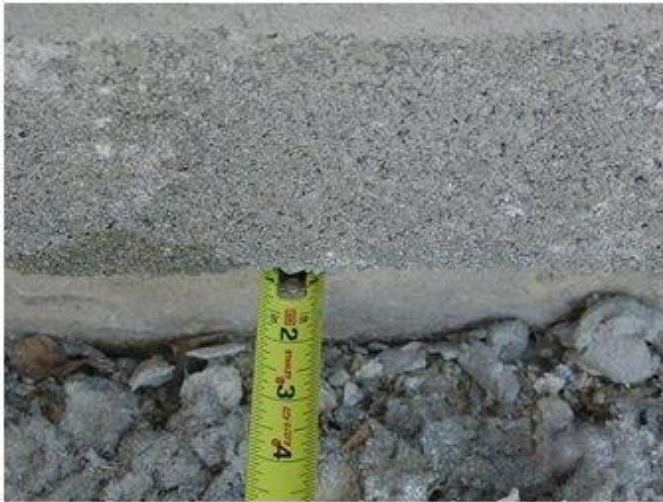
Issue: Concrete block masonry exterior wall overhangs slab by approximately 1 inch – face shells not in full bed of mortar (not fully supported)

Photo 01 – Code Violation section(s) for concrete blocks in masonry exterior walls overhanging slab 2014 FBC-R 606. 2014 FBC-B 2104.1 (Both reference ACI 530: face shells to be fully bedded.)	Photo 02 – Code Violation section(s) for no overflow drain (both roof drains are at the same elevation)  2014 FBC-R R903.4.1 2014 FBC-B 1503.4.1
Photos 03, 04, 05 are same item – Code Violation section(s) for Steel placed such that the minimum 1-1/2" concrete cover will not be attained 2014 FBC-R 611.1 2014 FBC-B 1901.2 (Both reference ACI 318: minimum cover requirements: earth contact – 3 inches; outdoor – 1-1/2 inches; interior – 3/4 inch.)	
Photo 05 – (see above for code violation)	Photo 06 – Code Violation sections for Hex head through bolts were specified – carriage bolts are not the same as hex head bolts 2014 FBC-R 107.4 2014 FBC-B 107.4
Photos 07, 08, and 09 are same item(s) – Code Violation section(s) for a) electrical panel was nowhere to be found; b) receptacle missing a) 2011 NEC 110.26 Working Space b) 2011 NEC 210.52(B) Small Appliances: (No small appliance receptacle outlet at the peninsula countertop space.)

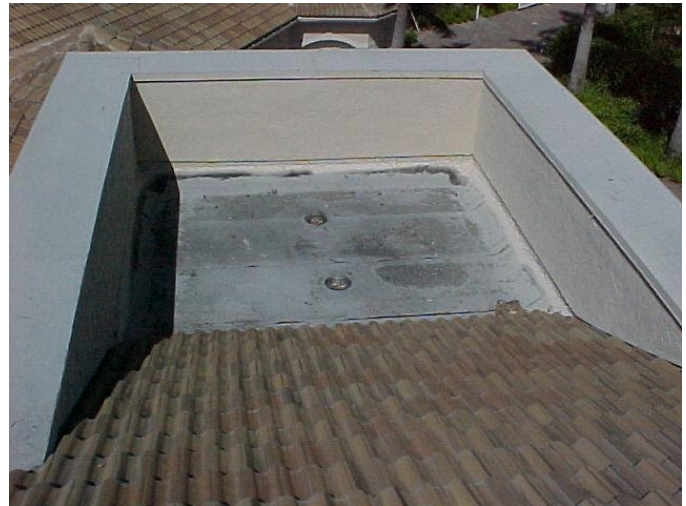
Photo 02

Issue: Roof drains – no overflow drain (both roof drains are at the same elevation)

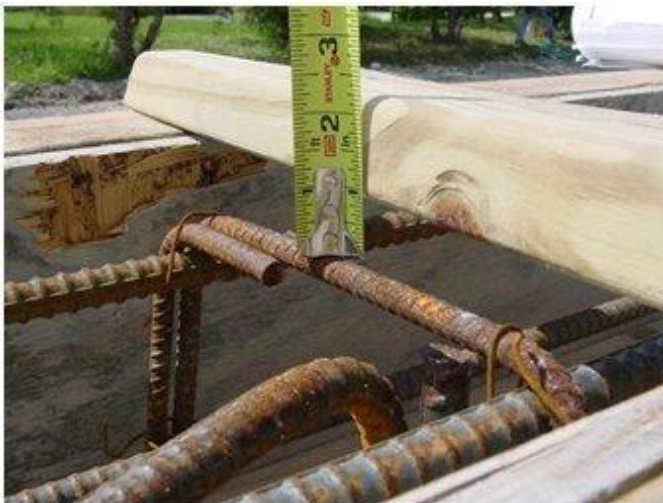
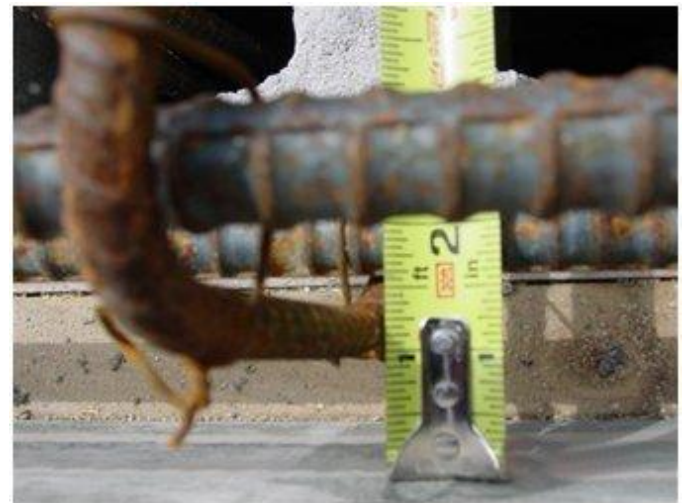
Photos 03 and 04 are of the same item – Photo 03 is top concrete cover, Photo 04 is side concrete cover

Issue: Steel placed such that the minimum 1-1/2" concrete cover will not be attained

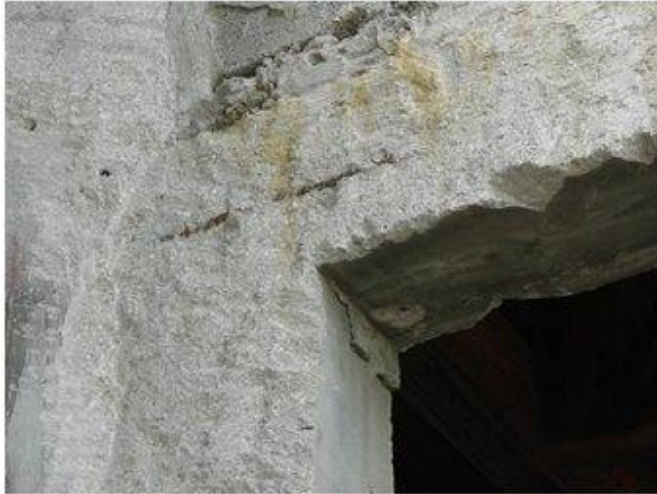
Photo 05

Issue: Concrete chipped off, exposing rebar, insufficient concrete cover

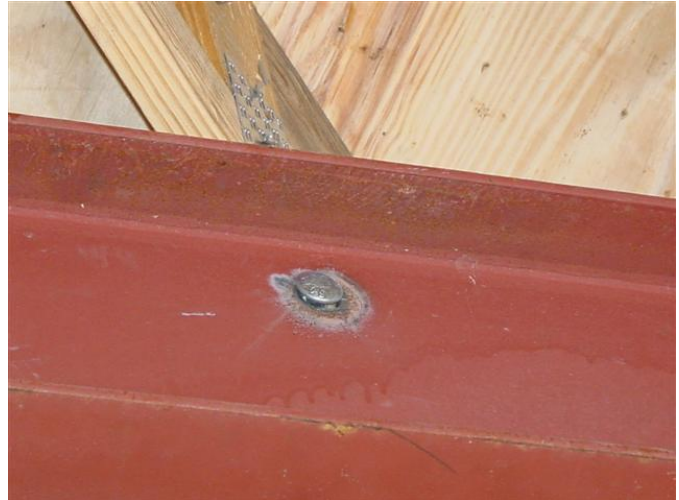
Photo 06

Issue: Hex head through bolts were specified – carriage bolts are not the same as hex head bolts

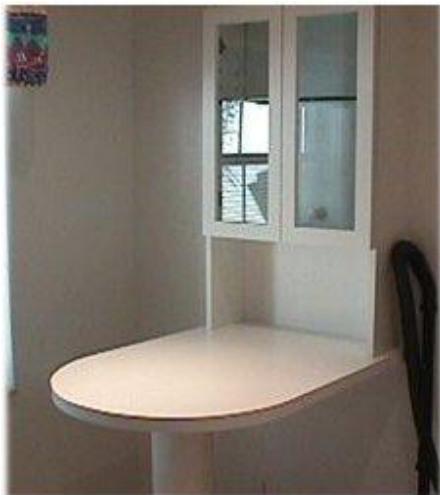
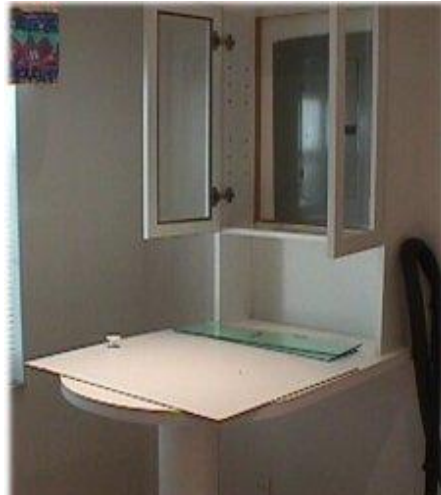
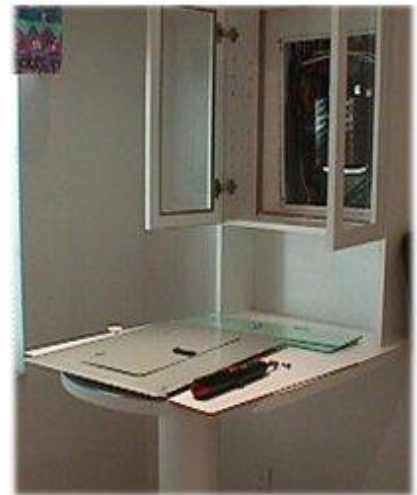
Photo 07

Photos 07, 08, 09 are of the same item

Issue: a) Final inspection of a kitchen remodel – the electrical panel was nowhere to be found.

The contractor was kind enough to show where the electrical panel was (proudly showing his ingenuity).

b) No receptacle at the peninsula countertop space.
